Manhole Inspection Summary

Manhole # S47I__003MH

Insp Date: **4/22/08 3:35 PM**

Location Address: **504 s collington av**

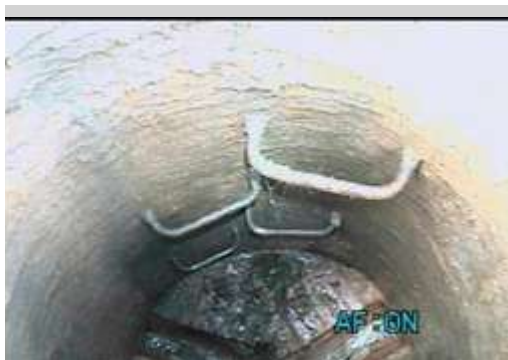
Defect 3

Count: **4** Missing: **0** ☒ Corroded

corroded stairs

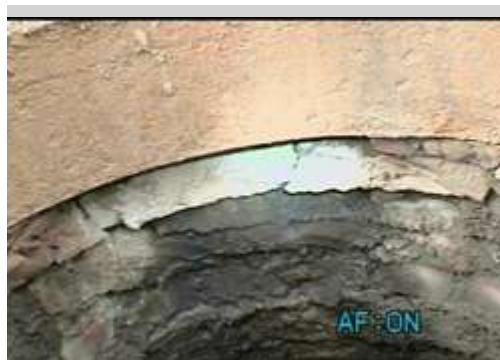
Defect 2

Condition: ☐ Sound ☐ Cracked ☐ Root Intrusion ☒ Loose Brick ☒ Deteriorated

loose bricks and deteriorated frame adjustment in chimney

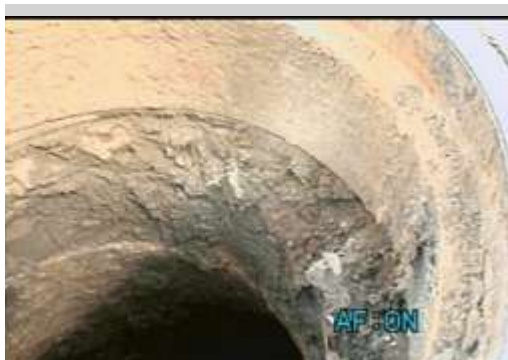
Defect 1

Offset: **2** (in.)

Infiltration: ☐ None ☒ Joint ☐ Cracks ☐ Mortar ☐ Roots ☐ Wall

frame offset, signs of infiltration at chimney joint

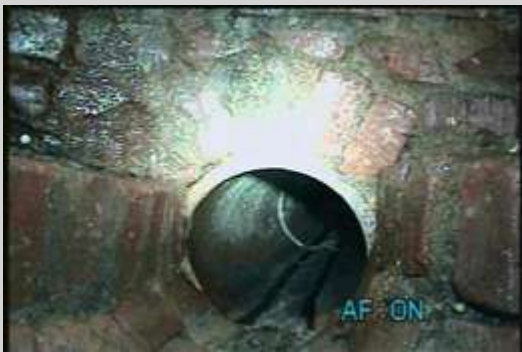
12 O'Clock Outflow

8 in. Circular Gravity Sewer
Pipe Out @ 12 O'Clock

Pipe Material: **Clay** ☐ Pipe Lined

Invert Depth: **9.33** (ft.) Flow Characteristics: **Fast**

Infiltration: **None** Pipe Seal Cond: **Unknown**

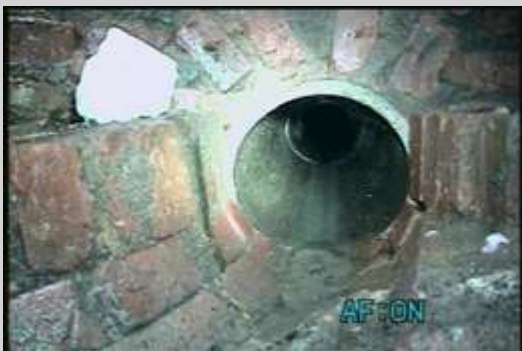
3 O'Clock Inflow

8 in. Circular Gravity Sewer
Pipe In @ 3 O'Clock

Pipe Material: **Clay** ☐ Pipe Lined

Invert Depth: **9.10** (ft.) Flow Characteristics: **None**

Connects To: **Dead End**

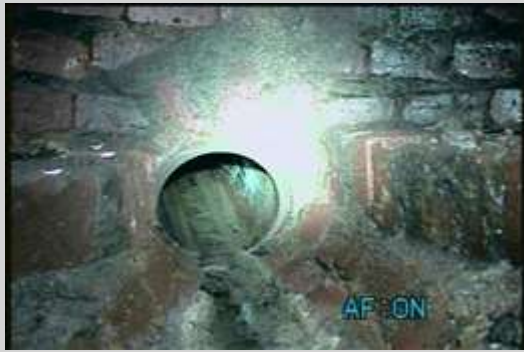
5 O'Clock Inflow

Pipe In @ 5 O'Clock

Pipe Material: **Clay** ☐ Pipe Lined

Invert Depth: **9.16** (ft.) Flow Characteristics: **None**

Connects To: **House connection / Service line**

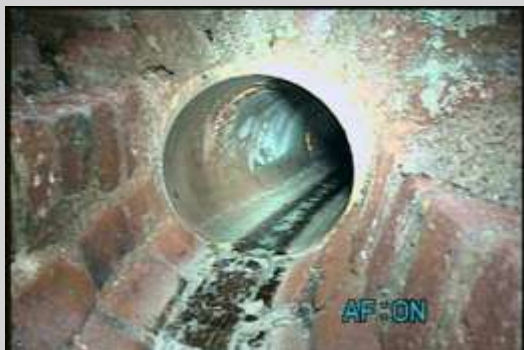
9 O'Clock Inflow

Pipe In @ 9 O'Clock

Pipe Material: **Clay** ☐ Pipe Lined

Invert Depth: **9.00** (ft.) Flow Characteristics: **Fast**

Connects To: **Manhole**
